Replacing 18th-Century Windows

Threaded rod and epoxy secure the replacement windows in this historic stone building

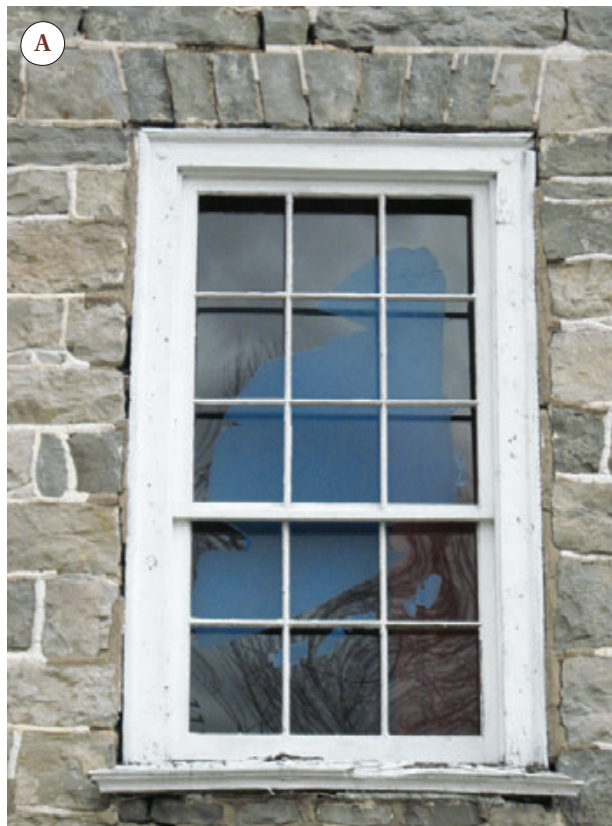
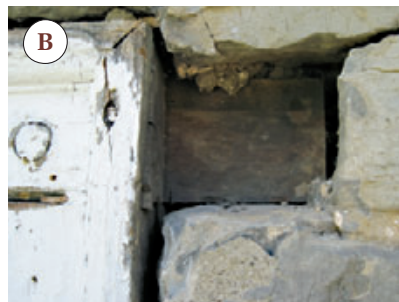
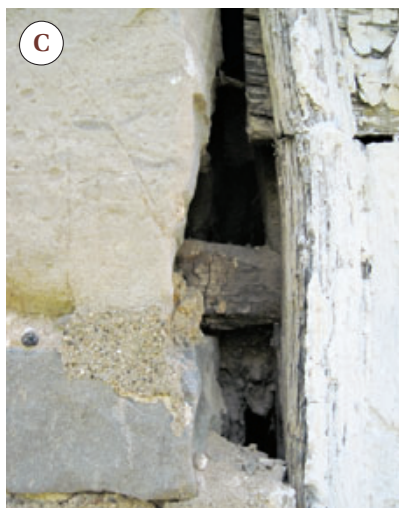
Figure 1. The old window frames were mortise-and-tenoned together (A). The top jambs had “ears” — extensions that allowed the window frame to be mortared securely in place (B). Where the stone got in the way, the original carpenters cut off the ears and inserted wood pegs for keying the bucks to the masonry (C).

Most likely, the assembled bucks were installed as the walls were being laid up. The sills and heads had “ears” that extended into masonry pockets on each side, allowing the frame to be mortared into place (see Figure 1, page 2). If the stone courses didn’t line up with the head, the carpenters inserted a large peg into the side of the jamb to serve the same purpose as the ear.

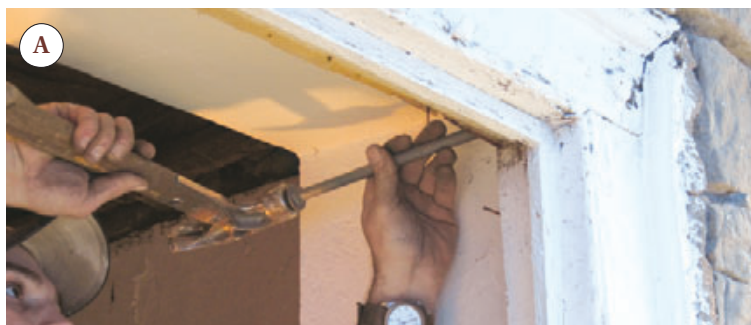
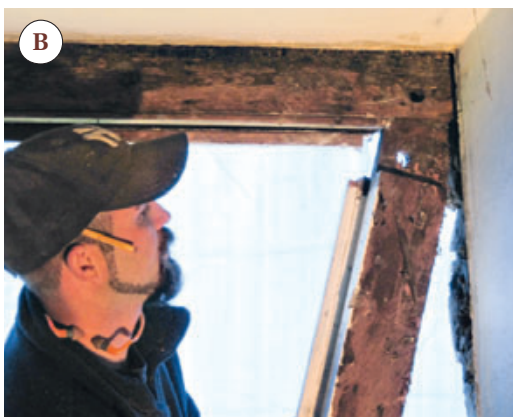
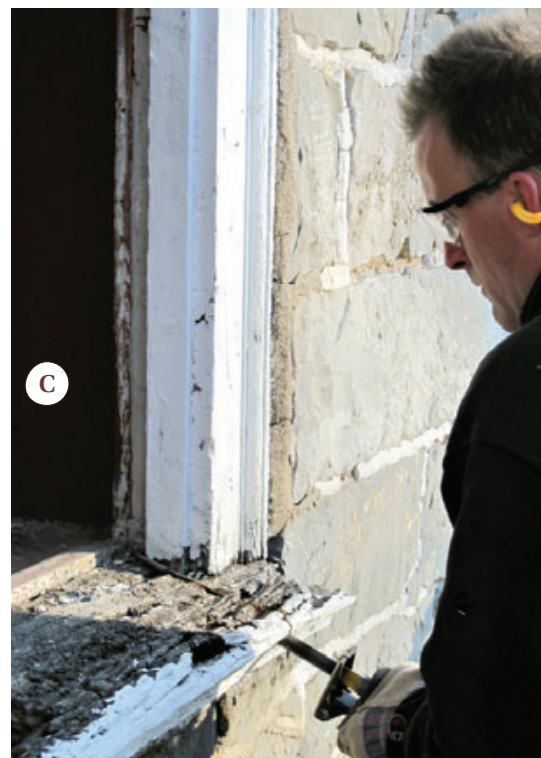
Figure 2. To remove a window frame, the author pounds out the peg securing the corner joint (A) and removes the side jamb (B). For windows whose jambs were in reasonable condition, only the sills were cut out (C).

With the casings removed, it was easy to knock out the pegs holding the side jambs to the head and pull out the sides of the buck (Figure 2, page 2). If the masonry was loose, the head jambs came out easily, but sometimes we had to cut through the ears to get them out.

condition except for the sills. On these windows, we cut through the tenon that extended from the jamb into the sill, then removed the sill, leaving the jambs in place.

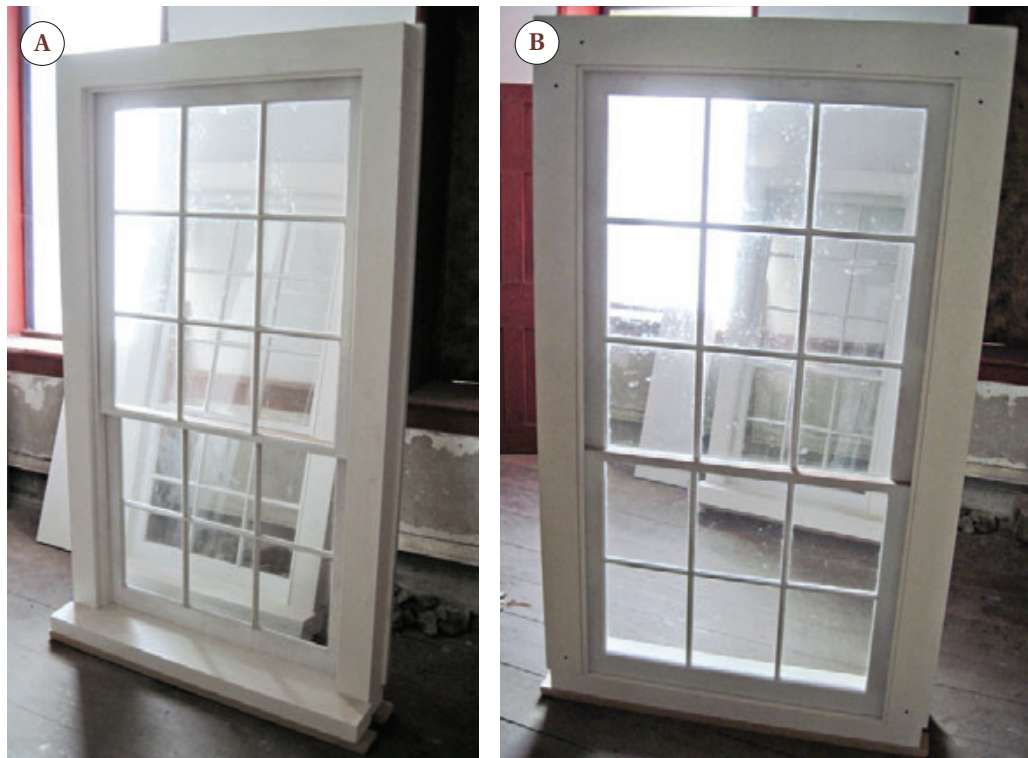
Figure 3. The replacement units (A) came with beaded interior casings tacked into place (B). The replacement sills matched the profile of the originals (C); they came primed and cut to length, but the carpenters had to scribe and cut out the returns on site.

New millwork. The replacement window frames were milled from white oak; the new sash and interior casings are Spanish cedar (Figure 3).

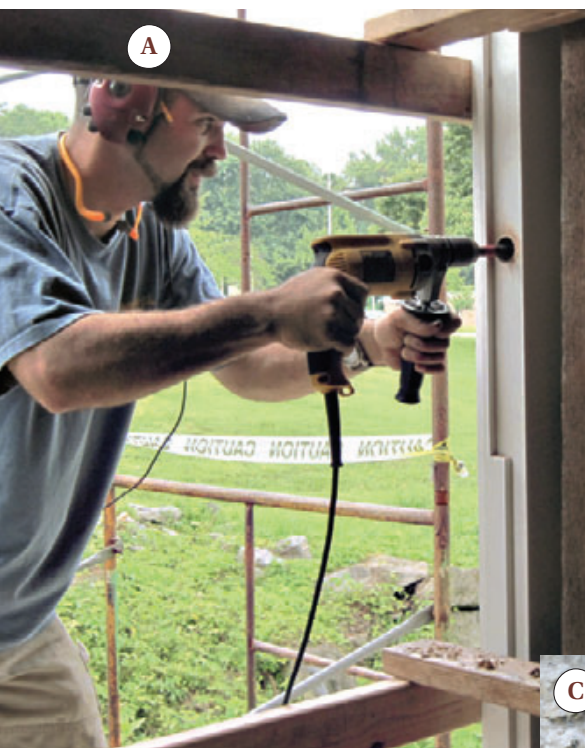
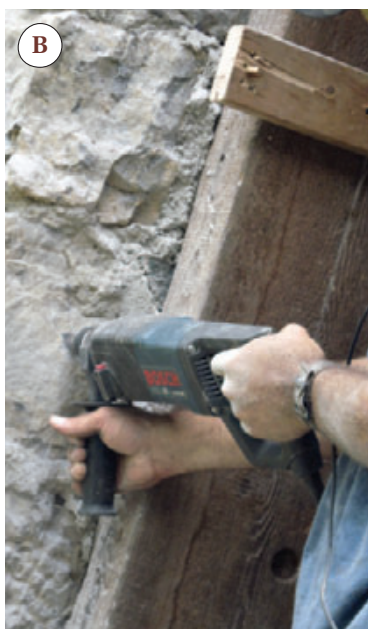
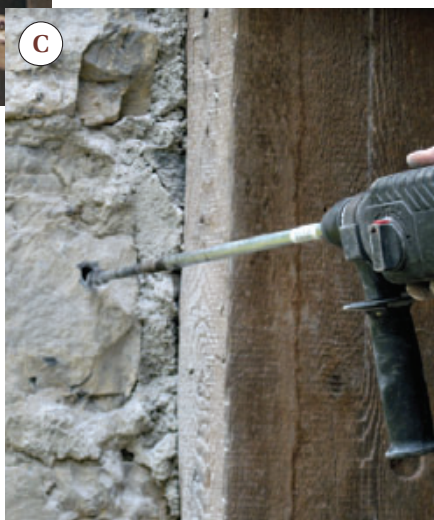
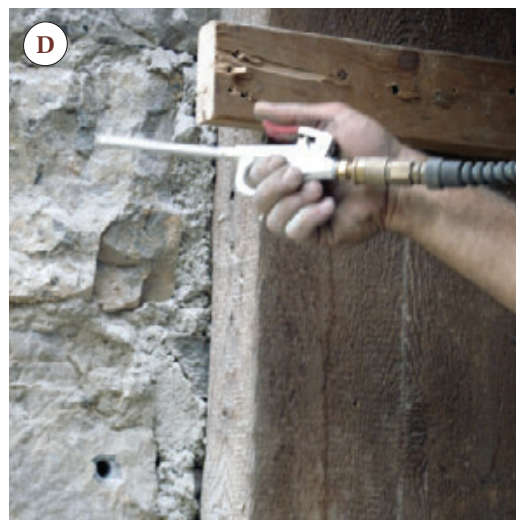
Figure 5. To attach a new wood window frame to the stone with threaded rod, the author first drilled a hole large enough to accommodate the washer and nut, using a wood countersink (A). To avoid ruining the bit, he continued drilling through the wood with a 1/2-inch masonry bit until he hit the stone. Then, with the frame out of the way, he continued drilling with a 5/8-inch masonry bit, making a hole large enough for the 1/2-inch rod and the epoxy (B). To ensure a good bond, he cleaned the hole with a wire brush (C) and compressed air (D).

Once the holes are marked and the window buck is in its exact position, we countersink a 1 $\frac{3}{8}$ -inch-diameter hole in the jamb deep enough to conceal the nut and washer and allow some room for the Abatron epoxy filler we use to finish the surface before painting (Figure 5, page 4).

Next we switch over to a hammer drill and complete the hole through the wood and into the stone. For the old jambs, we chuck up a $\frac{5}{8}$ -inch-diameter masonry bit and continue into the stone to the required depth. With the replacement bucks, we finished drilling through the wood jamb with a $\frac{1}{2}$ -inch-diameter bit, creating a tight hole for the threaded rod

When the $\frac{1}{2}$ -inch bit hit the stone, we removed the new window buck, switched to a $\frac{5}{8}$ -inch bit (which allows room for the epoxy), and kept drilling to the 3-inch depth. It takes a little longer to pull the window buck out of the opening before continuing to drill, but it's worth it because that $\frac{1}{2}$ -inch hole in the wood frame helps lock the windows into place when we eventually install them. With the old jambs that remained in place, there was a little more wiggle between the

After the holes are drilled in the stone, they have to be thoroughly cleaned for the epoxy to bond well. We used a blow nozzle and a brush attachment on the hammer drill.

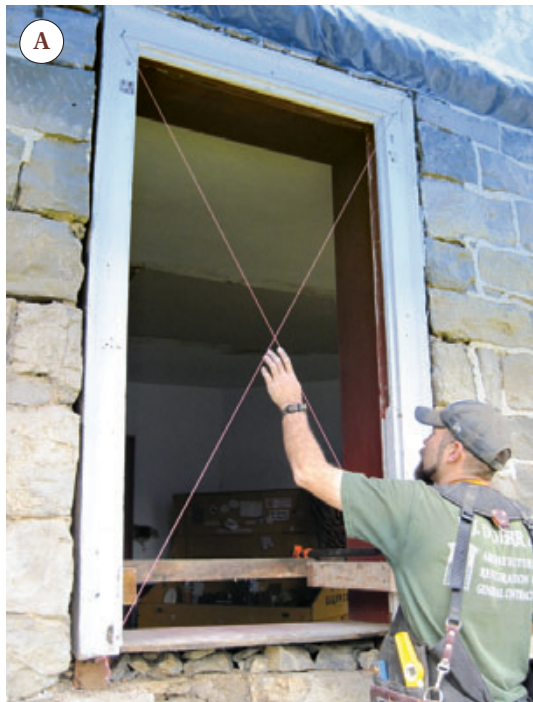
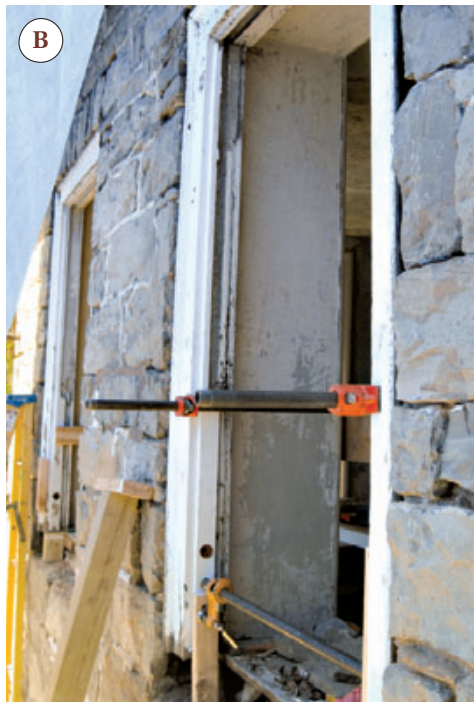
Figure 6. Before replacing the sills of the original window frames, the crew made sure the head and jambs were in plane (A), then clamped them in place (B) and drilled the holes for the epoxy anchors (C). With the jamb bolted in place, the mason repairs the window well before the primed sill is installed (D).

We started the replacement work with those windows that needed only new sills. The first step was checking the bucks to make sure they were square and in plane — not too likely after 200 years of settling (**Figure 6, page 5**). Correcting problems at this stage would make it easy to fit the new sash easier later on.

held the jambs in exact position before drilling the anchor holes. Then, with the long Hilti nozzles, we squirted in the epoxy and inserted the threaded rod, being careful not to overtighten the nuts at this stage, which might distort the jambs. After the epoxy set up, we mortared the gap between the jamb and the stone, then made minor adjustments to the nuts, bringing the jambs into final position. Once all the bucks were fastened, we finished the holes with an Abatron epoxy filler.

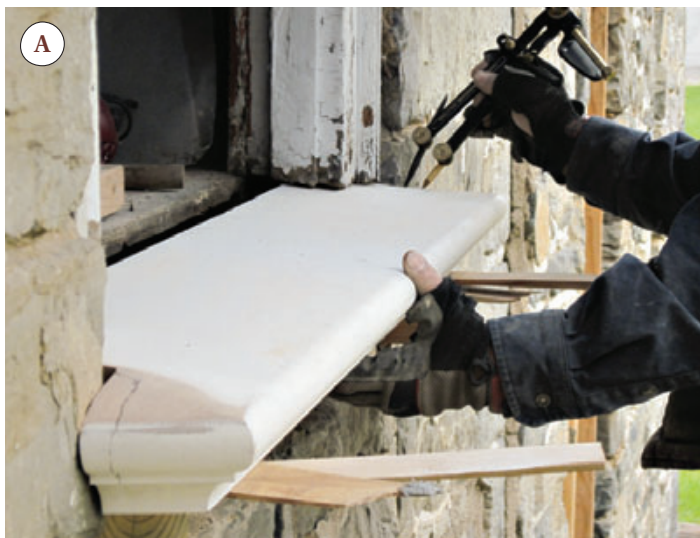
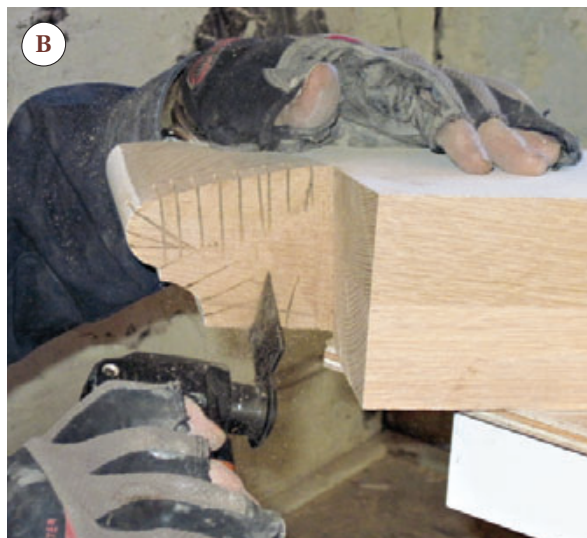
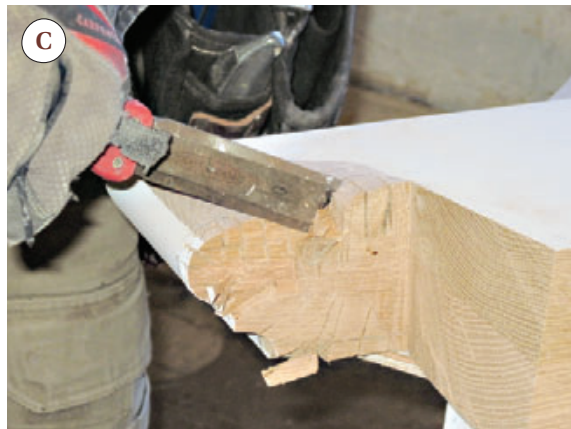
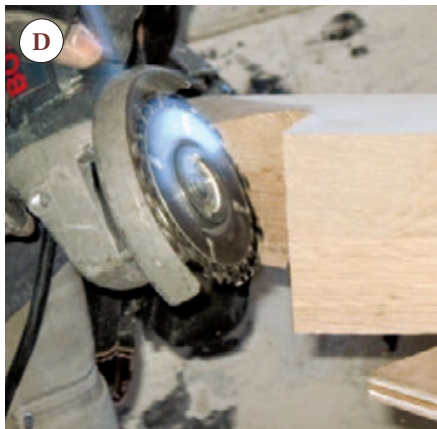
Figure 7. After scribing the replacement sills in place (A), the author used a multi-tool to kerf to the lines (B), then a chisel to remove the waste (C). A grinder with a carving blade was useful for matching the three-dimensional stone surface (D).

the return, then scribed the sills in place (**Figure 7**). Because of the irregular stone surface, removing the material to the scribe lines was a bit tedious. A jigsaw was out of the question. What worked best was a combination of a multi-tool, a chisel, and a grinder fitted with a chainsaw blade. We used the multi-tool to kerf up to the scribe lines, then a chisel to waste the bulk of the stock. The grinder with the carving wheel did the final tweaking. Be careful the first time you use this setup in a grinder — it can chew up the work very quickly.

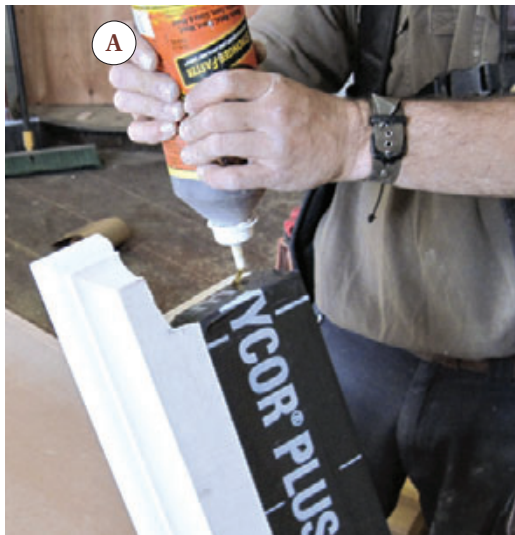
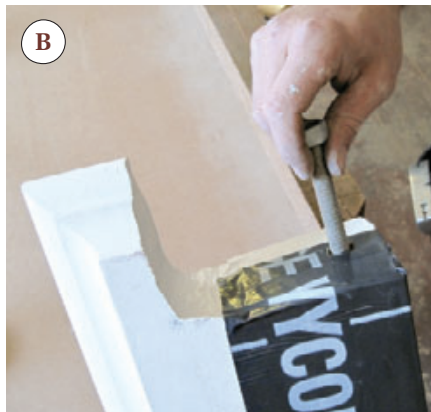
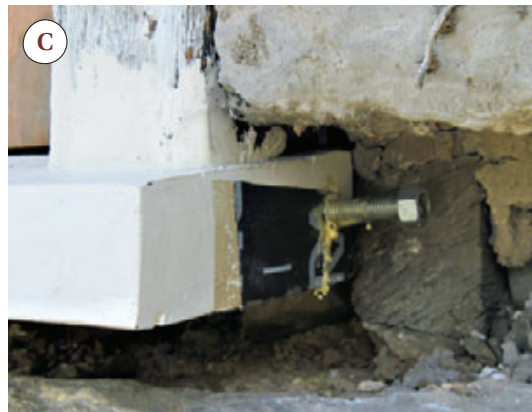
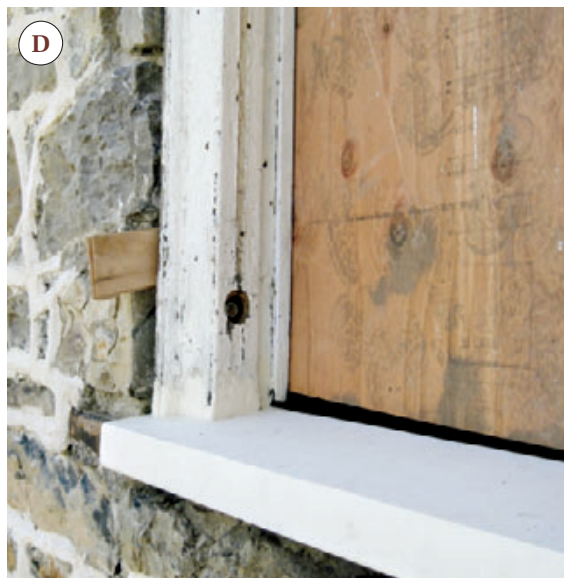
Figure 8. Threaded rod glued in holes in the ends of the replacement sills (A, B) served the same purpose as the wood extension “ears” on the original sills — providing anchorage in the masonry (C). The old jams were first epoxied to the stone, and the new sills attached from the bottom with lag screws driven at an angle from beneath (D).

that all cut edges — as well as the bottoms of the jambs — received two coats of oil primer. We also isolated as much wood as possible from the masonry with Vycor peel-and-stick (Figure 8).

The original bucks had been held in place with ears that extended into the masonry from each end of the sill. We achieved the same effect by drilling $\frac{5}{8}$ -inch holes about 6 inches deep in the ends of the sills and inserting threaded rod, which we secured with polyurethane glue. We fastened the sills to the bottom

of the jambs with Timberlok screws; later, the threaded rod extensions were mortared into place.

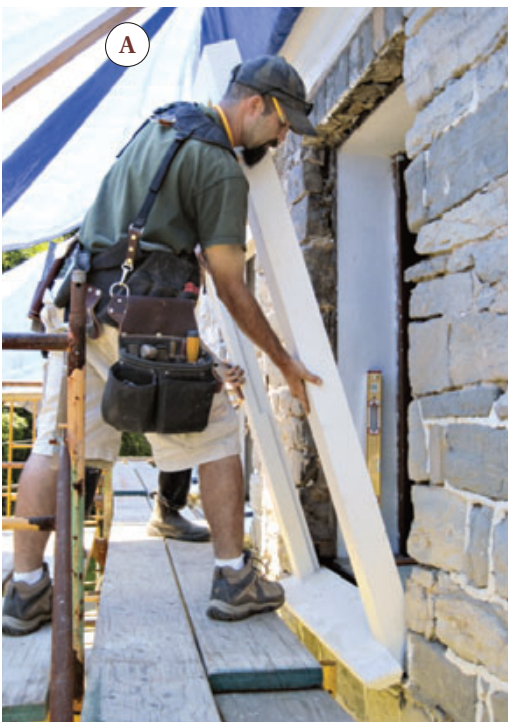
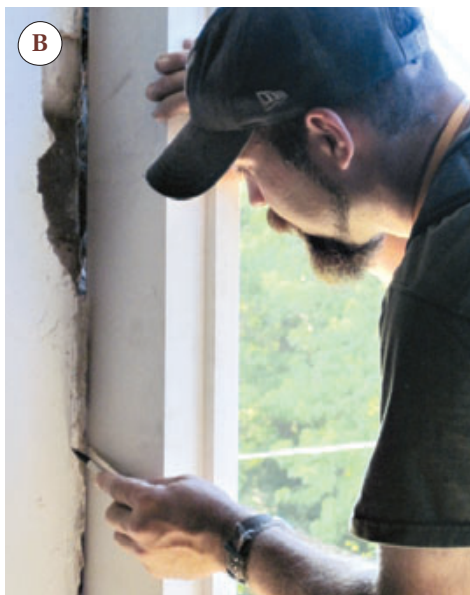
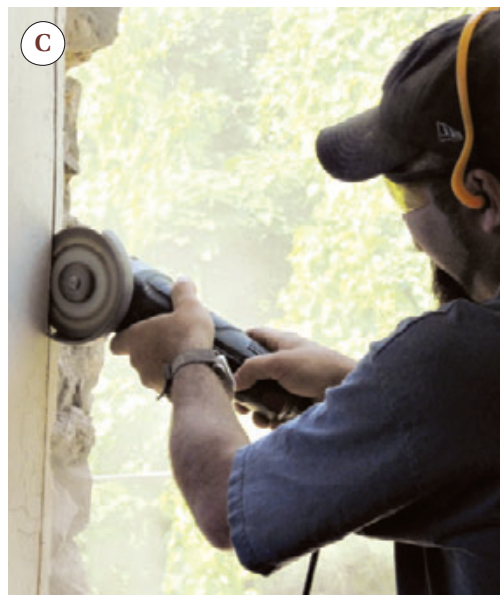
Figure 9. To provide a tight fit for the new interior casing, which would have to be installed from outside, the author temporarily positioned the replacement buck (A) and scribed an offset line on the plaster in the window well (B). He then removed the frame and cut the line with a grinder (C).

We also scribed the sides of the interior window well for the replacement casings (Figure 9, page 7). Once we were satisfied with the fit, we pocket-screwed the interior casings together and fastened them in place, followed by the window buck itself, which we wrapped on all four sides with peel-and-stick (Figure 10). We secured the window unit in exact final position with clamps and temporary braces, then drilled the holes for the epoxy anchors.

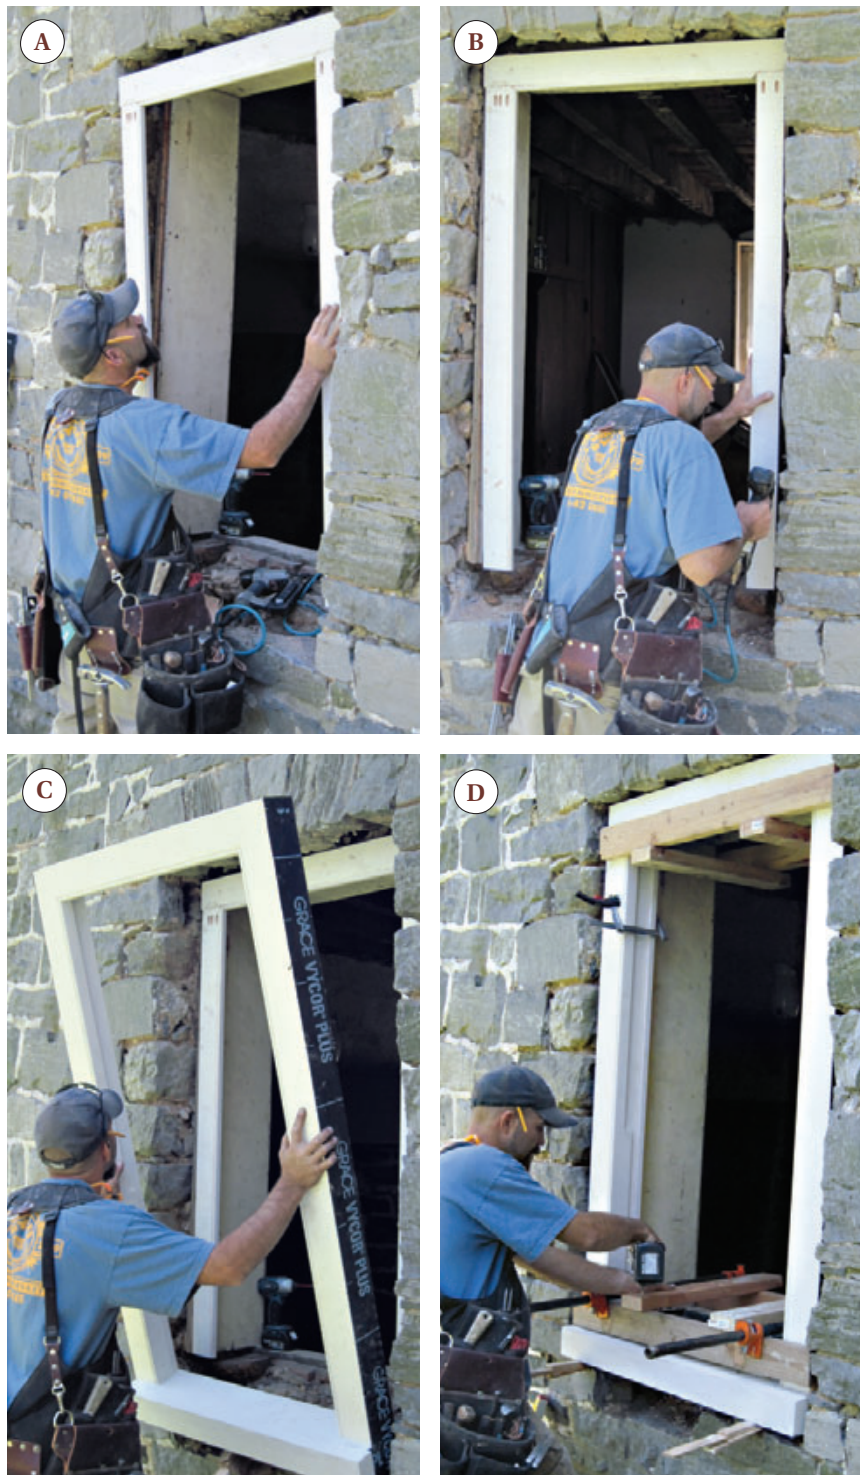
Figure 10. Before the new window frame could be installed, the casing had to be pocket-screwed together (A), then positioned from outside and tacked into place (B). The window frame, protected on all four sides with peel-and-stick membrane, was then set in the opening (C) and secured in its final position in preparation for installation of the epoxy anchors (D).
