Replacing Giant Columns

A methodical approach yielded masterful results in this oversize remodeling project

by Noah Woodruff

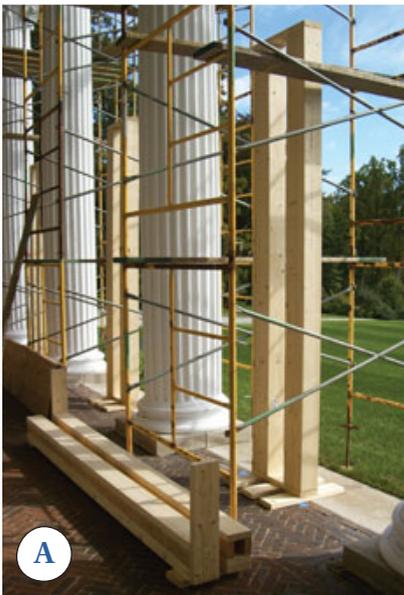
Figure 1. To temporarily support the porch roof while the columns were replaced, the carpenters built posts from 10-foot-long 2x4s and 2x6s (A). The double-post assemblies were joined by top and bottom plates stacked two high (B), then sheathed with 1/2-inch plywood (C). Full-length 2x4 strongbacks were added to the outside for rigidity.

Next we built five jacking “towers” (see **Figure 1, next page**), on top of which we placed 20-ton hydraulic jacks. The towers would support the architrave and roof, but we would also need to hold the weight of the columns. For this purpose, we had two-piece steel clamping rings fabricated by a local metal shop (**Figure 2, page 3**). By bolting these rings to the column above the cut line, we could safely support the columns while we worked on them. Once

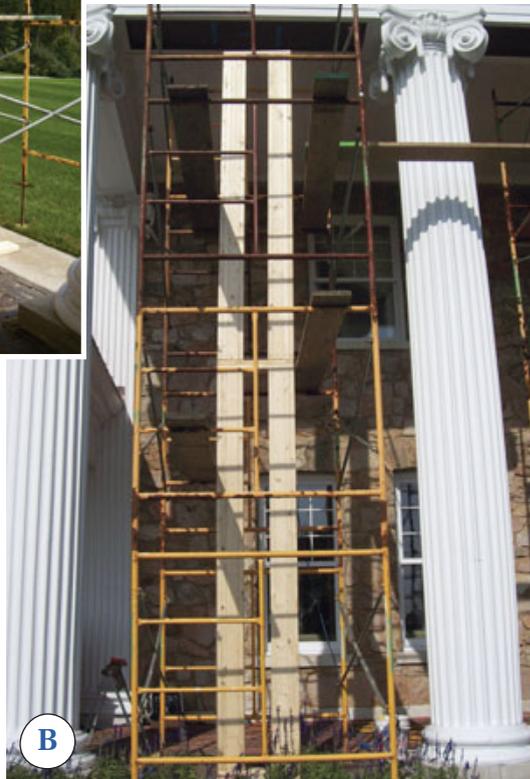
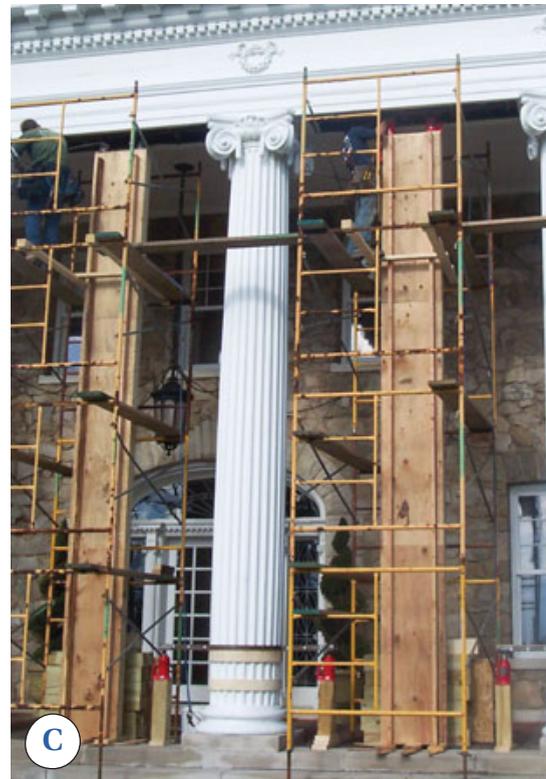
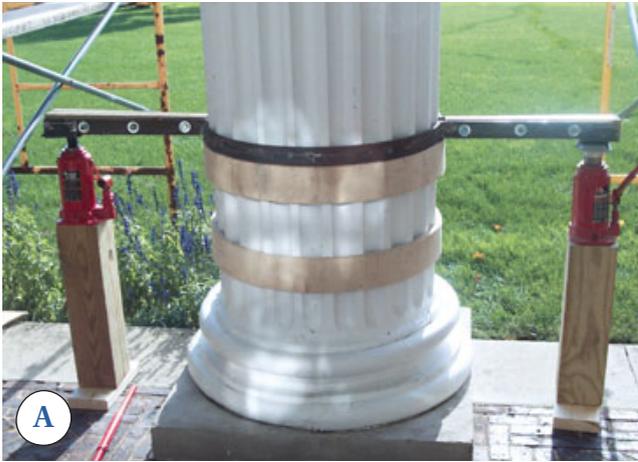
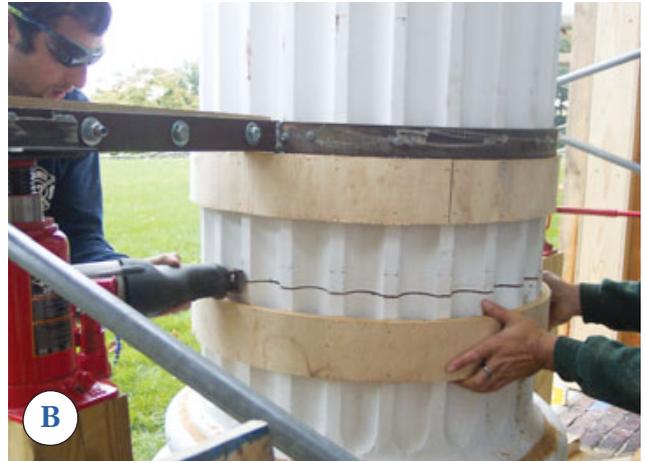
Figure 2. The original plan was to replace only the column bases. Accordingly, the crew installed structural steel clamp rings around the shafts (A) and shifted the weight from the pedestals to the concrete porch using 20-ton hydraulic jacks. Rings of bending plywood served to guide the cutting of the wood columns, which was done with reciprocating saws (B) and circular saws (C). Removing the bases (D) confirmed that the interiors were delaminating and that the columns would have to be replaced.

Best-laid plans. With two jacks per tower, the architrave and roof lifted easily, as did the columns. Cutting the columns proved more difficult. After making saw guides from bending plywood, we started in with a Big Foot wormdrive saw, hoping its 4-inch cutting depth would allow us to cut through in one pass. However, as we began to cut, the saw began to bind — it felt as though the inside staves of the

laminated column were coming apart. We drove screws through from the outer layer into the inner layer, tying everything together. We abandoned the Big Foot and instead used a standard circular saw, finishing the cut with a recip saw.

Once the first column had been cut completely through, our suspicions were confirmed: The inner staves were delaminating because the glue was failing. The engineer advised that the columns would have to be replaced. We cut and cribbed the remaining columns (**Figure 3, next page**) and suspended the job while the homeowners decided how to proceed. It was the end of September 2009.

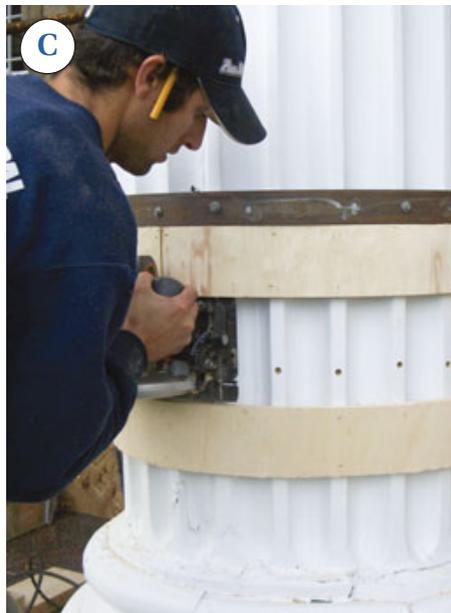
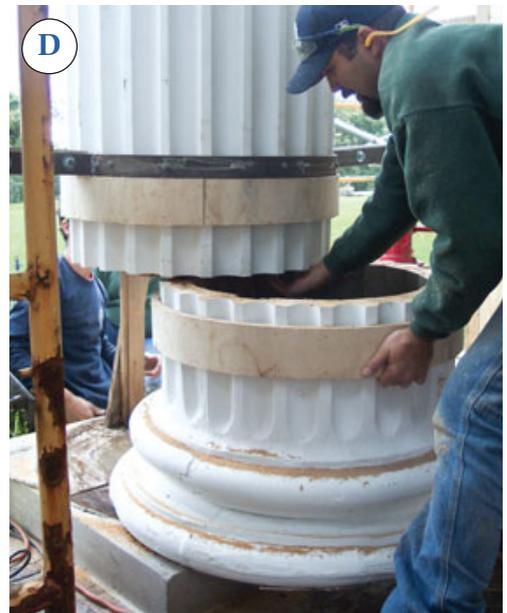
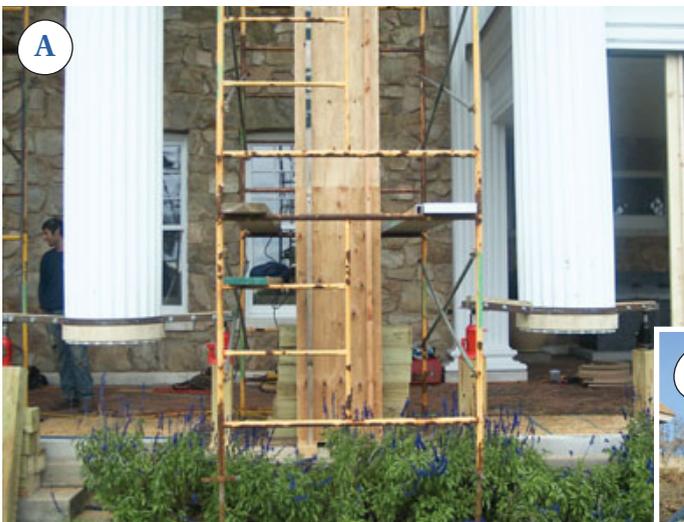
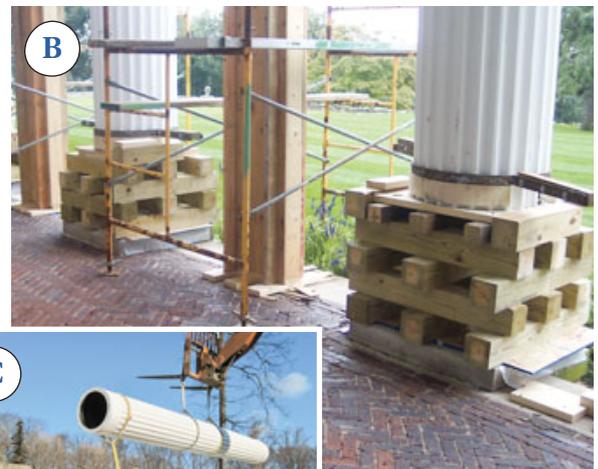
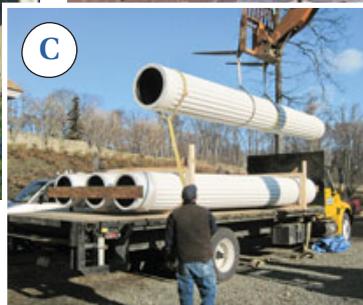
Figure 3. After cutting away the bases (A), the crew placed cribbing under the shafts (B) while awaiting the delivery of new columns (C).

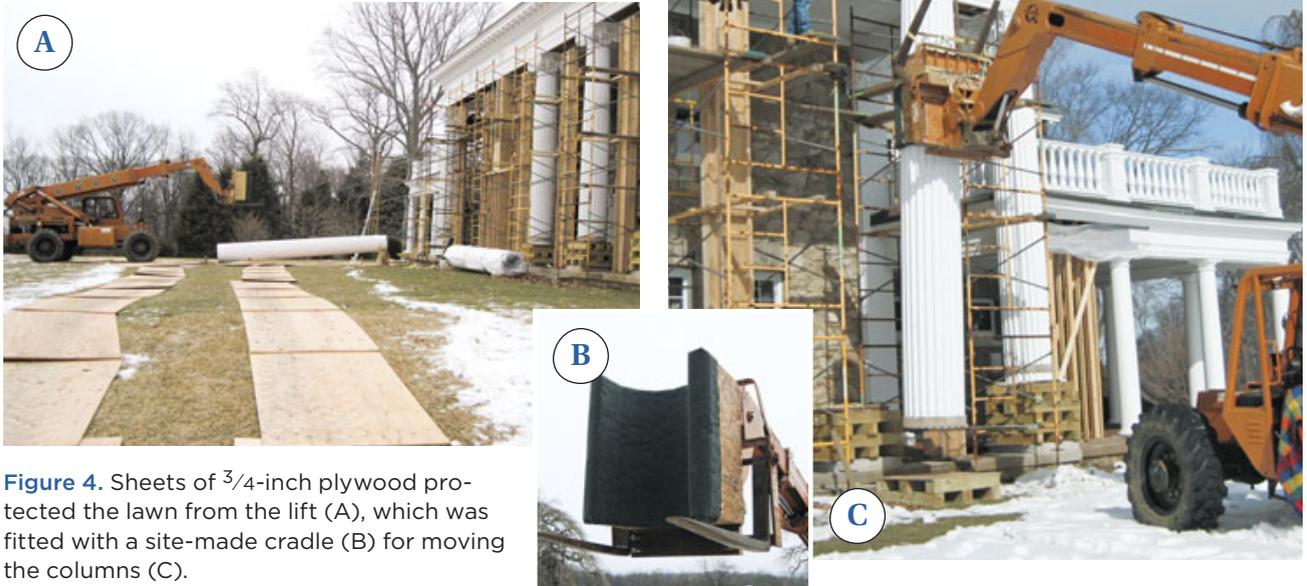
Figure 4. Sheets of $\frac{3}{4}$ -inch plywood protected the lawn from the lift (A), which was fitted with a site-made cradle (B) for moving the columns (C).

The new columns weighed over 1,200 pounds apiece. In order to move them, we brought in an extended-reach forklift. To protect the lawn from the machine, we laid out 40 sheets of 3/4-inch plywood, creating a path between the drive and the front of the house (**Figure 4, page 4**). This turned out to be a good idea, as there was lots of precipitation during the course of the job; twice, the site received more than 18 inches of snow.

We moved the columns from the staging area using a pair of straps. Once the column was in front of its final location, the lift operator used a single strap attached near its top to swing it into a vertical position and set it on a temporary platform in front of the porch, where we secured it to the scaffolding for stability. Because there was so little clearance

for the new columns between the bottom of the architrave and the top of the limestone plinth — only about $\frac{3}{4}$ inch — there was no way to move the column into place with the strap attached. So we fashioned a cradle for the lift that allowed the operator to pick up the column by the shaft. Working from the scaffolding, we attached the columns to the cradle with three ratchet straps, then the lift operator — with a very steady hand — inched them into place. We also used the cradle for removing the original columns.

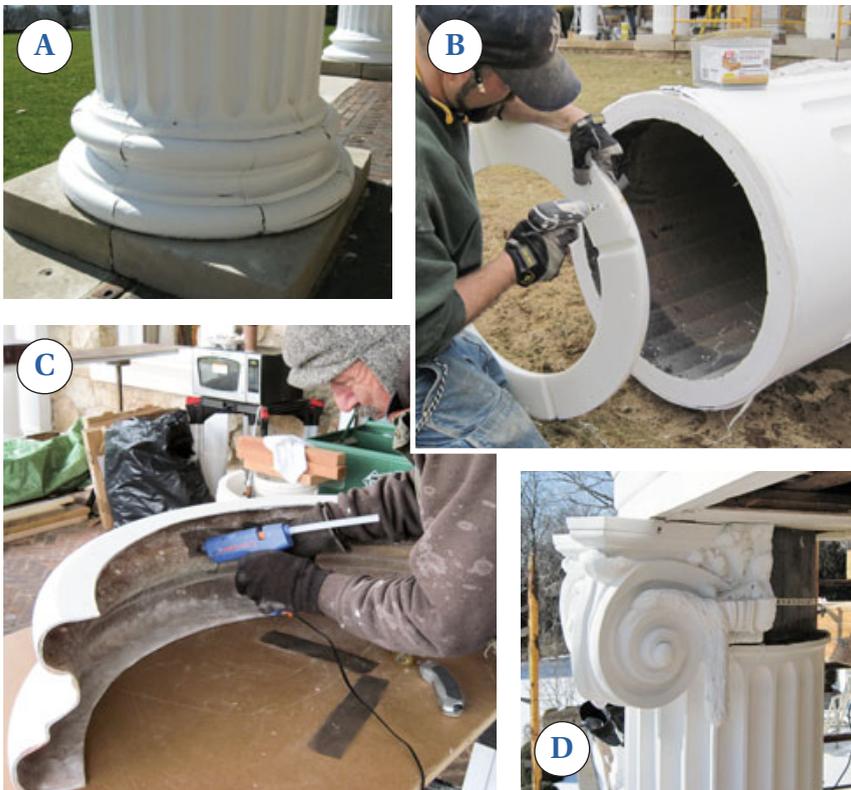
Figure 5. To prevent the moisture degradation that had affected the existing columns (A), the crew installed polycarbonate spacers on the bottoms of the new columns, thus isolating the wood from the damp stone plinths (B). Two-piece fiberglass bases replaced the old wooden ones (C); vent holes drilled in the bases were covered with screen to keep bugs out. The original fiberglass capitals (D) were salvaged and reused.

To prevent moisture from wicking up into the new columns, we screwed 1-inch-thick polycarbonate spacer rings, supplied by the manufacturer, to their bottoms before we installed them (Figure 5). In addition, we drilled a series of 1-inch holes around the bottom of the columns to provide ventilation. These holes were covered by new two-piece fiberglass base assemblies, in which we also drilled vent holes, on the bottom of one of the radius moldings where they couldn't be seen. On the inside we glued insect screens over the holes to keep bugs out.

We also drilled vent holes in the tops of the columns. These holes were covered by the hollow two-piece fiberglass capitals that we salvaged and reinstalled. To complete the ventilation path, we installed two 2-inch-diameter louvers in the back of each capital where they wouldn't be obvious. We also added several 1-inch louvers in areas of the capitals

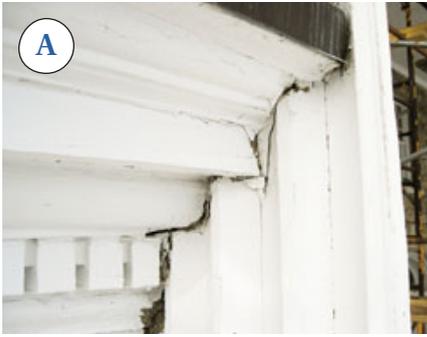
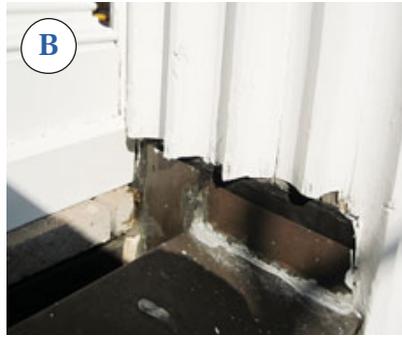
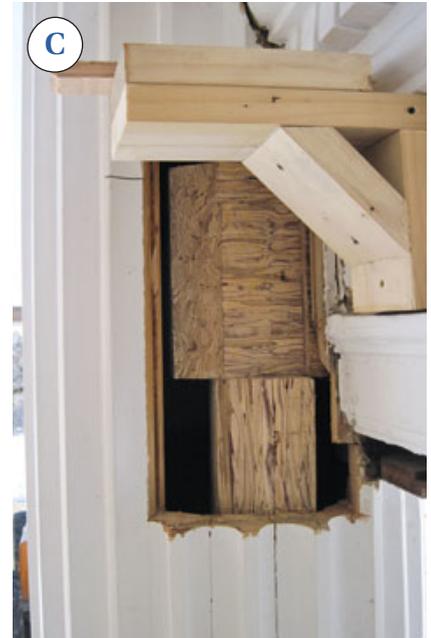
Figure 6. Replacing the columns at each end of the porch was complicated by scribed trim (A) and abutting rooflines (B). One of these columns also concealed a Parallam post that supported the end of a load-bearing beam (C, D).

Because of all the scribed trim and intersecting rooflines (Figure 6, previous page), the columns at each end took a lot longer to

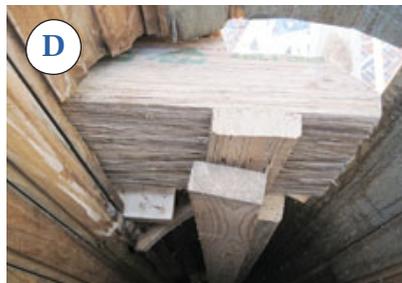
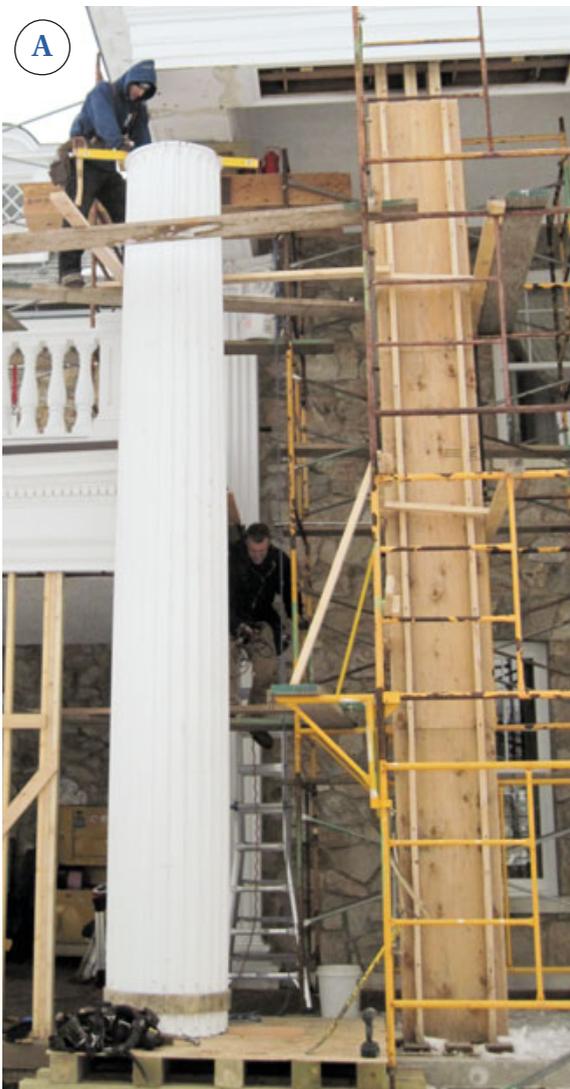
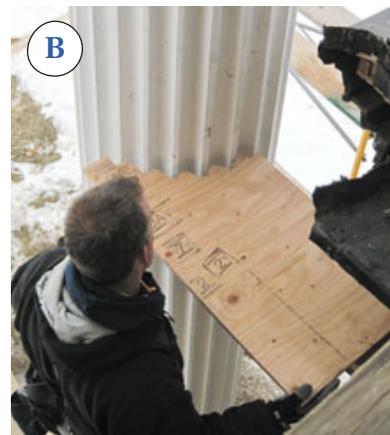
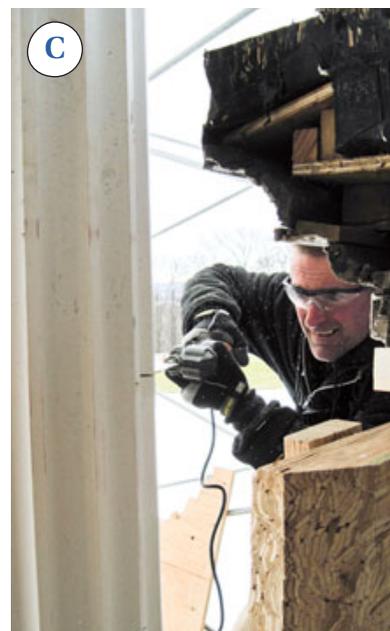
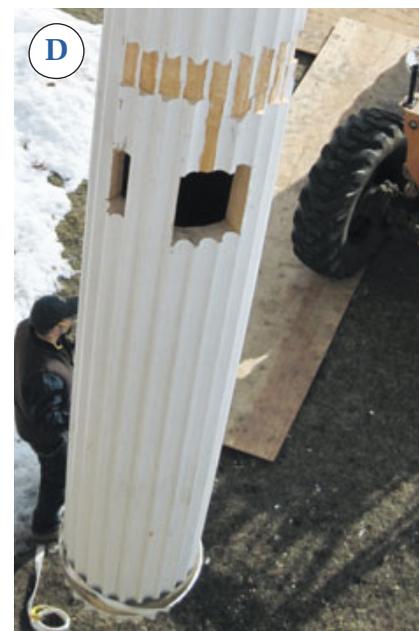
Figure 7. At the end of the colonnade, the carpenters used one of the old columns to practice scribing to the adjoining porch roofline (A). A plywood template helped in orienting the flutes to the existing trim (B). Where the support beam of the adjacent deck dies into the column, a recip saw (C) was used to create the beam pocket (D).

We also had to carefully cut beam pockets to receive the ends of structural girders from the abutting porches (Figure 7, page 5). Plywood jigs helped us align the flutes with the previously scribed moldings. We actually practiced the cuts on an old column first, which allowed us to rehearse the entire process before trying it on one of the new columns (Figure 8, previous page).

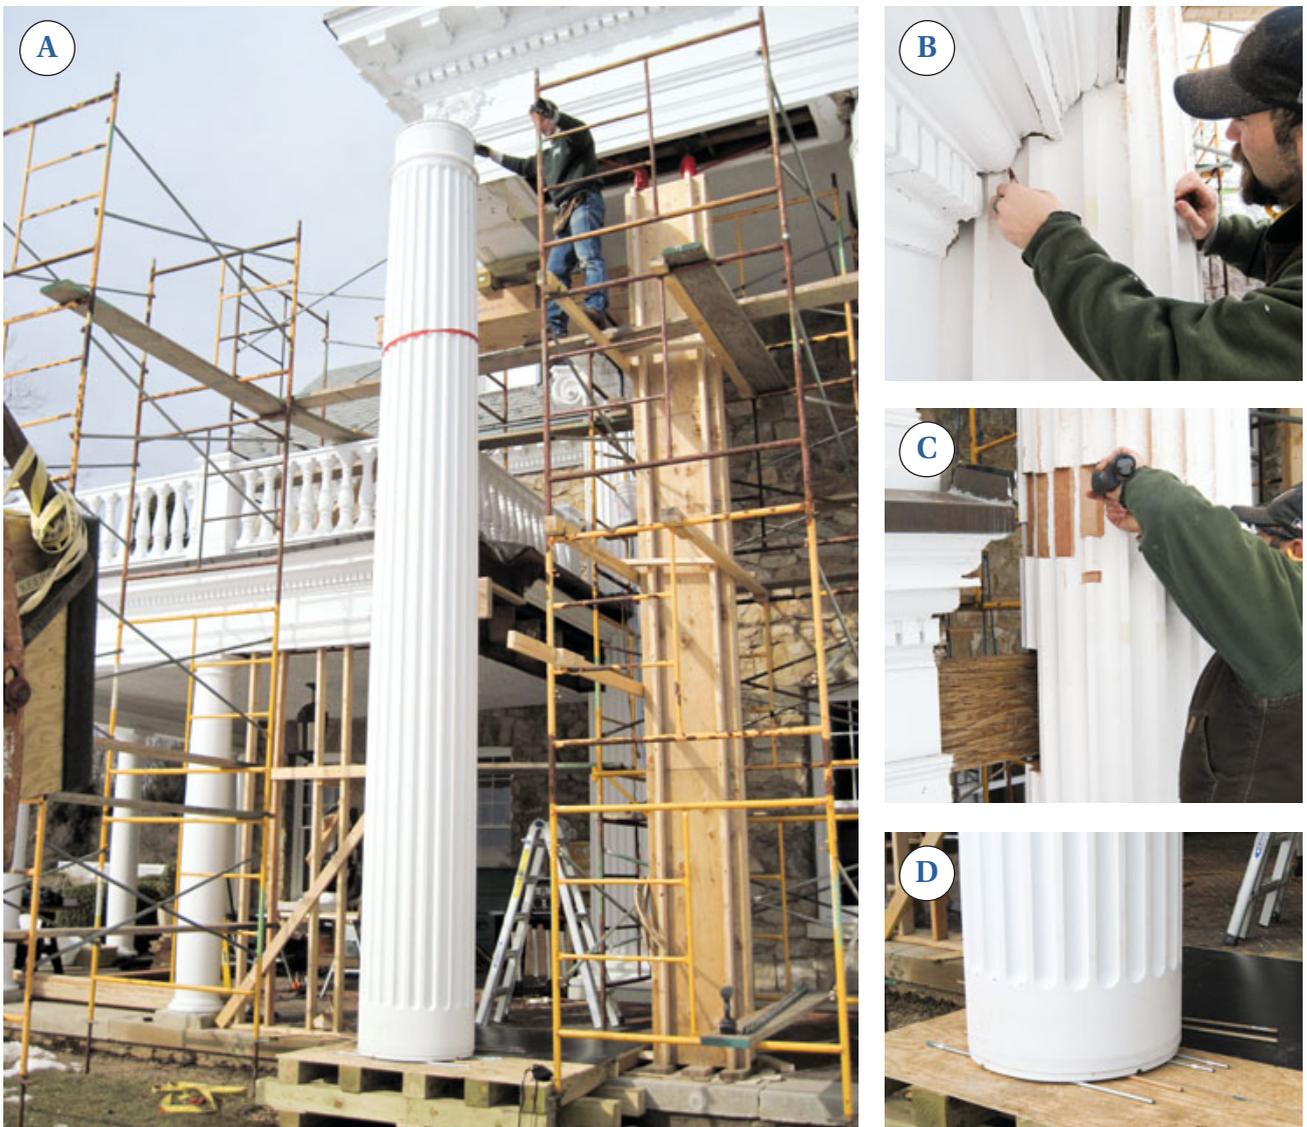
Figure 8. Once the practice column was moved, the new corner column was set in place (A). In a series of back-and-forth moves, the column was scribed and fitted to the adjoining trim (B, C). To facilitate the process, the crew created a solid, level base covered with plastic laminate just in front of the column's final location (D). They experimented with rollers, but found that two men could slide the column across the slippery laminate without them.

install than the middle four columns. We knew we would have to move these columns back and forth to achieve a tight fit, so we first built staging platforms in front of and in the same plane as the corner plinths. We covered the staging platforms and the plinths with plastic laminate, initially thinking this would protect the limestone plinth from the wood and steel dowels we placed under the column to enable it to roll back and forth.

After a couple of moves, however, we realized that there was very little friction between the polycarbonate ring on the bottom of the column and the plastic laminate, and that two men could actually slide the column back and forth without using the dowel rollers. Suffice it to say, it took many moves back and forth to properly align and scribe the new columns to the existing moldings and rooflines,

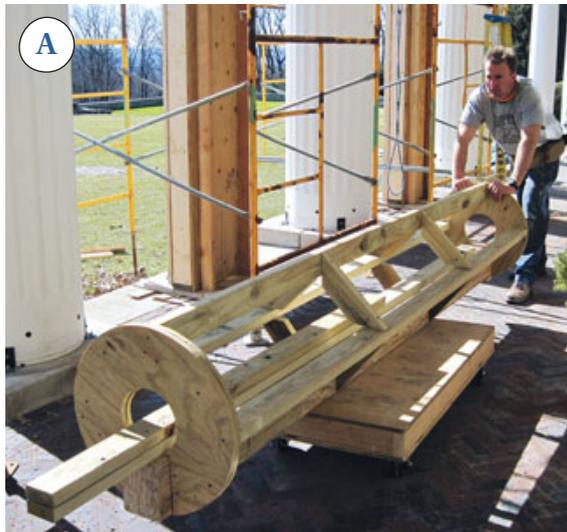
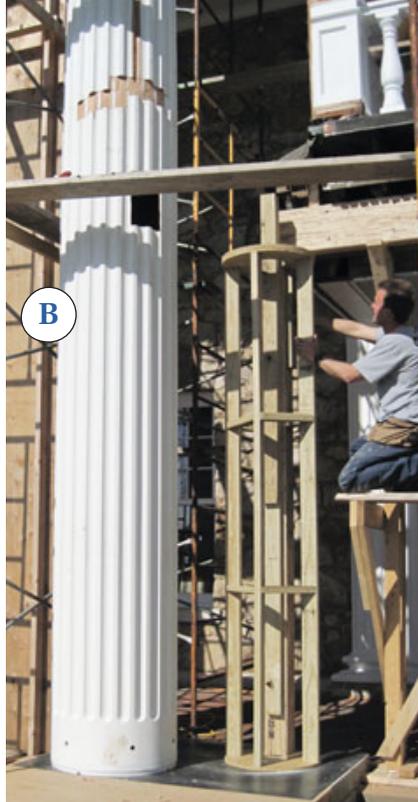
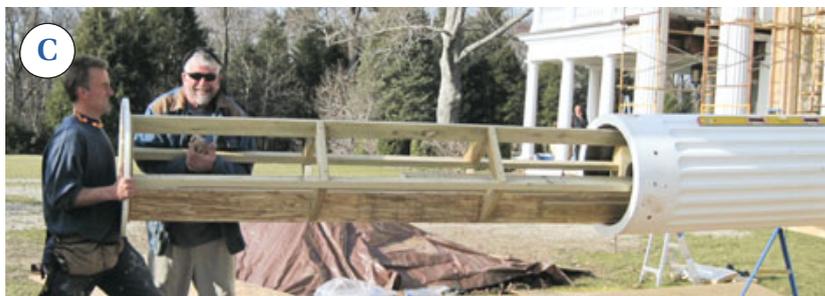
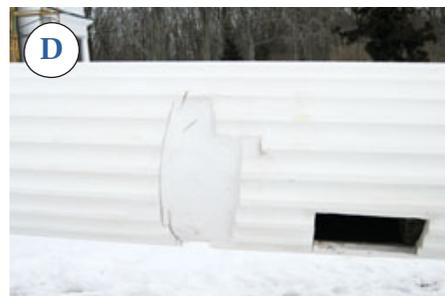
Figure 9. A round support pedestal (A) was built to replace the Parallam post in the old corner column. After carefully checking its final position on the porch (B), the carpenters slid the pedestal — dubbed “the plug” — into the column (C), where it was secured with lag screws driven from the outside. The raw wood of the scribed column was primed (D) before final installation.

Structural plug. As mentioned above, one of the corner columns housed a structural post that supported the end of a porch girder. The girder had been added during a previous remodel, to support the

extra load created when the rooftop deck was covered with heavy masonry pavers. The builder had inserted the post by simply cutting a wedge out of the column, then patching it back in.

We wanted to do something a little cleaner, so instead we built a structural “plug” that would be inserted into the column before we set it in position (Figure 9). We framed the plug like a small round room, with radiused top and bottom plates and studs in between. We used $\frac{3}{4}$ -inch pressure-treated plywood for the plates, and framed in a $5\frac{1}{2}$ -inch by $5\frac{1}{2}$ -inch Parallam post to support the girder. We also had to allow for the taper of the column, meaning the top of the plug was slightly smaller than the bottom.

column into place “empty” to test fit it — to the end of the beam, the entablature moldings, and the porch railing. Once we were satisfied, we had to move the column back onto a set of horses so we could install the plug, which we did by pushing the snug-fitting assembly inside and securing it with LedgerLok screws driven from the outside.

Then the lift operator had to once again stand up the column with straps, attach it to the cradle, and move it back into place. When the column was close, we manually slid it into place. We had to twist it as it went so that the projecting beam landed inside the beam pocket (which was only $\frac{1}{2}$ inch wider than the beam) and so that the flutes aligned correctly with the entablature and the porch rails. It was a challenge we don’t care to repeat.

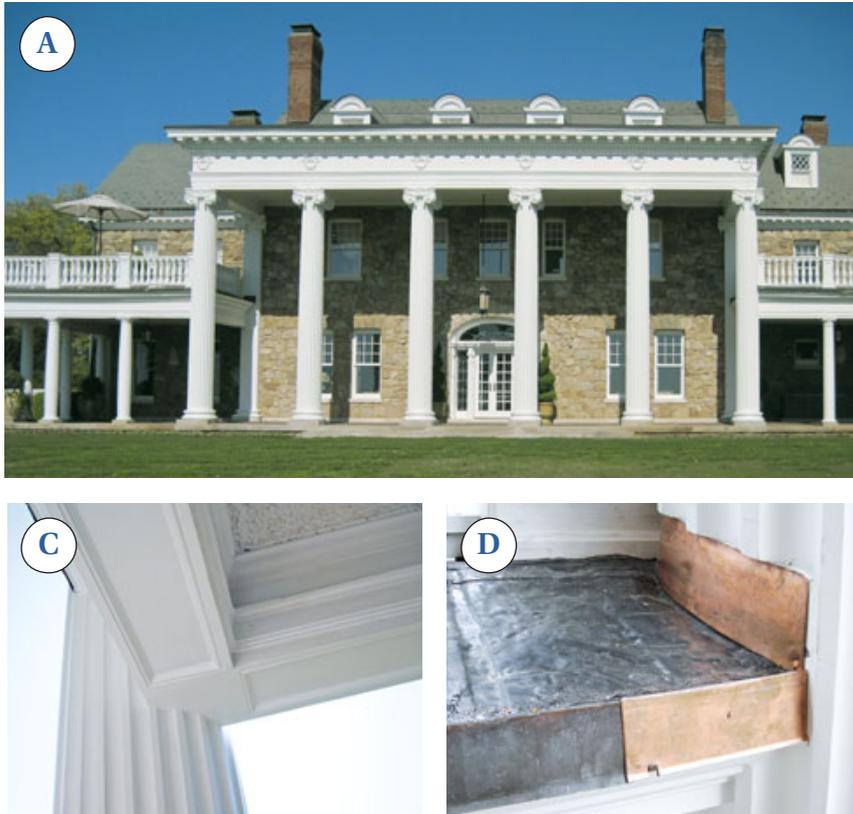
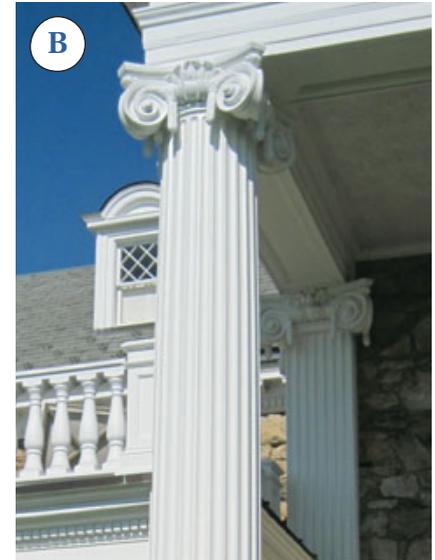
Figure 10. The finished job matches the original perfectly (A). The original two-piece fiberglass capitals were reinstalled (B) and new trim scribed to fit (C). Where adjoining roofs meet the column, a rubber membrane was adhered to the shaft, then covered with copper (D).

The final step was patching the rubber roofing. The previous roofers had installed a tar-and-copper curb against the column, attempting to follow the radius and patching with cement where necessary. This didn’t seem like the best approach — besides being unattractive, it would be prone to leaks. Instead, at the spot where the roof deck met the column,

we ground back the flutes to create a flat area. We primed the bare wood, then adhered rubber roofing to the column and covered it with new copper flashing.

After we finished our work, the painters came in. When they were done and the scaffolding — which had been up for eight months — came down, it looked as if we had never been there (Figure 10).
