Replacing 18th-Century Windows

Threaded rod and epoxy secure the replacement windows in this historic stone building

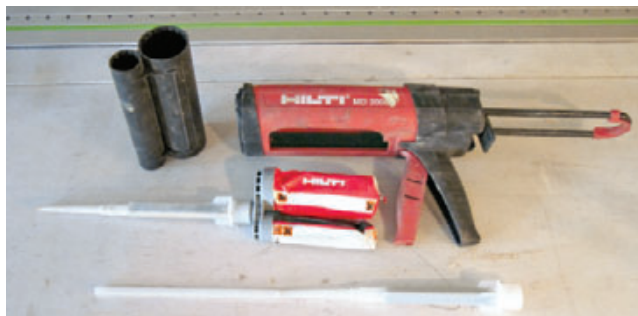
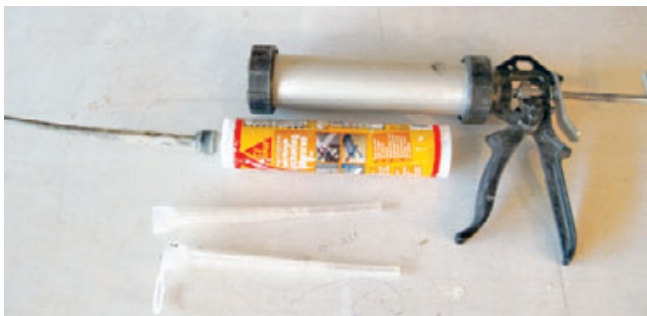
Figure 4. The author's crew used two types of epoxy — a two-part from Hilti (left) that is installed with a proprietary gun and a single-part from Sika that is delivered with a standard sausage gun (right). The long nozzle on the Hilti gun was helpful for injecting the epoxy through the thick window bucks.

On the job shown here, we used 1/2-inch stainless-steel rod and two brands of epoxy, Hilti and Sika (**Figure 4**). We ended up preferring the Hilti system for one reason: The two-part adhesive comes with an extra-long nozzle that makes it easier to squirt the epoxy into the stone through the thick window bucks. This was helpful for the windows whose original side jambs remained in place. Unfortunately, though, each pack of epoxy includes only one tip and our local supplier doesn't stock them, so on complicated jobs like this we have to plan ahead and order extras. We go through a lot of tips because the particular Hilti epoxy we use sets up quickly — especially when the weather is warm.
